NATIONAL TRANSPORTATION SAFETY BOARD

MATERIALS LABORATORY FACTUAL REPORT

Report No. 21-081

Place : Pine Grove, Oregon
Date : August 23, 2020
Vehicle : Kaman K-1200, N314
NTSB No. : WPR20LA283
Investigator : Fabian Salazar, ASI-WPR

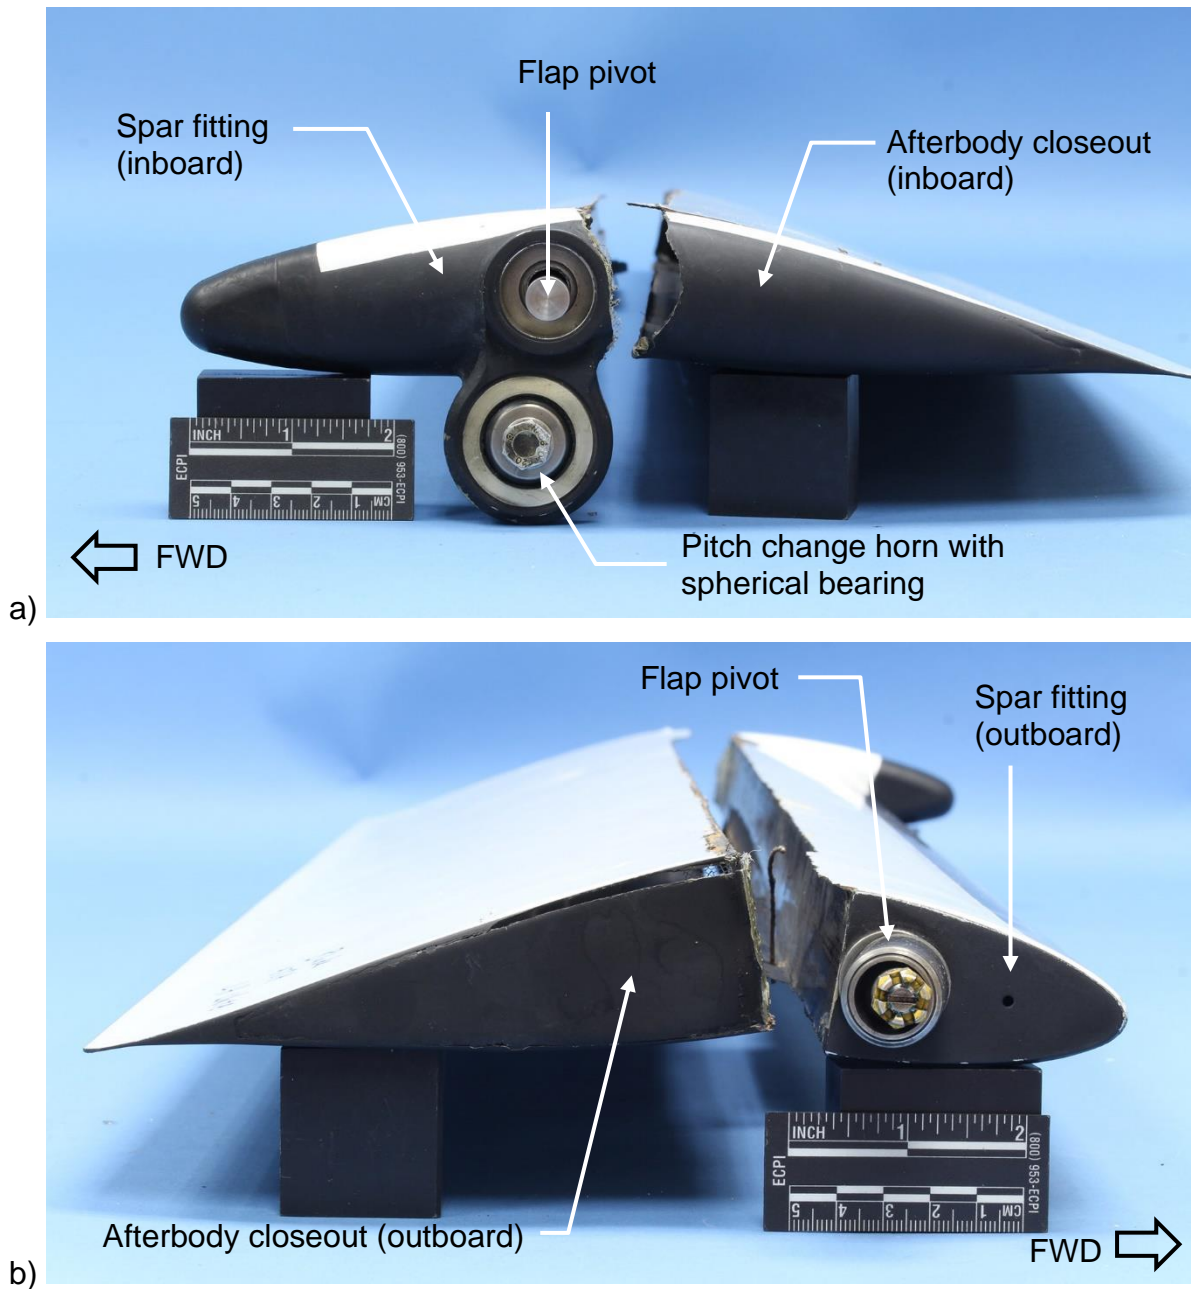
Figure 14. End views of the separated servo flap: a) inboard end viewed looking outboard and b) outboard end viewed looking inboard.

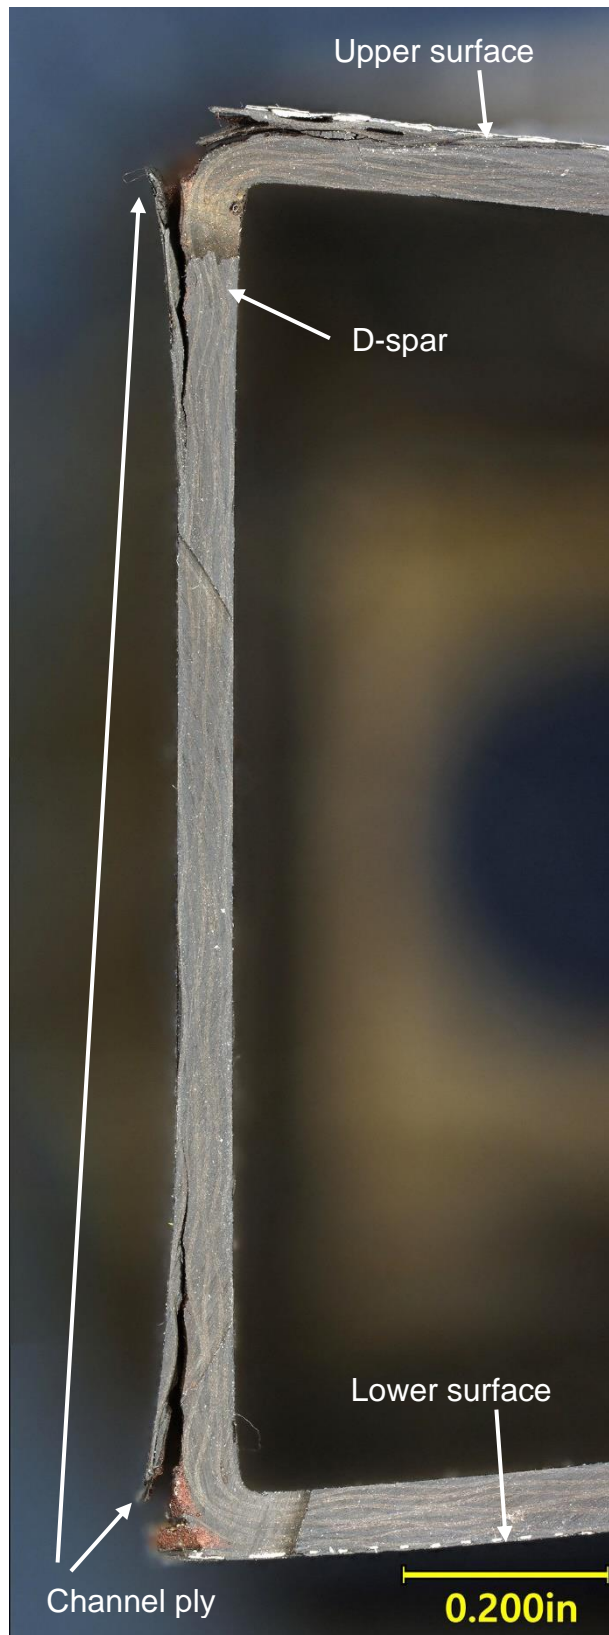
The separation occurred generally at the spar-to-afterbody transition along the spanwise direction with some regions of peel separation. Along the lower surface, the two skin plies had fractured at or near the spar-to-afterbody transition and the channel ply exhibited peel separation from the spar along the entire spanwise length. An example of the peel separation is shown in figure 16 where the spar was sectioned at approximately STA 4.25.

The channel ply had also peeled from the spar along portions of the upper surface. The primary region, seen in cross section in figure 16 at STA 4.25, started at the inboard end, gradually decreased in depth, and eventually ended at approximately STA 23. A secondary region was observed along the outermost 2 inches of the spar. Along the upper surface, the channel ply fractured primarily at the transition bend between the spar and the upper skin, with two exceptions: The first exception was between STA 19.5 and 21.5 (figure 21a), close to the end of the primary channel ply peel region. The fracture had moved down from the edge of the spar by a single transverse tow. The other region was associated with the secondary peel region (figure 21b) at the outboard end of the flap. Two inches from the end, the overlaid warp tows had peeled from the spar and fractured down from the edge by a single transverse tow. The fracture gradually moved down the

Figure 16. Cross section through spar at approximately STA 4.25 showing peel separation and fracture of channel ply. The view is looking inboard.

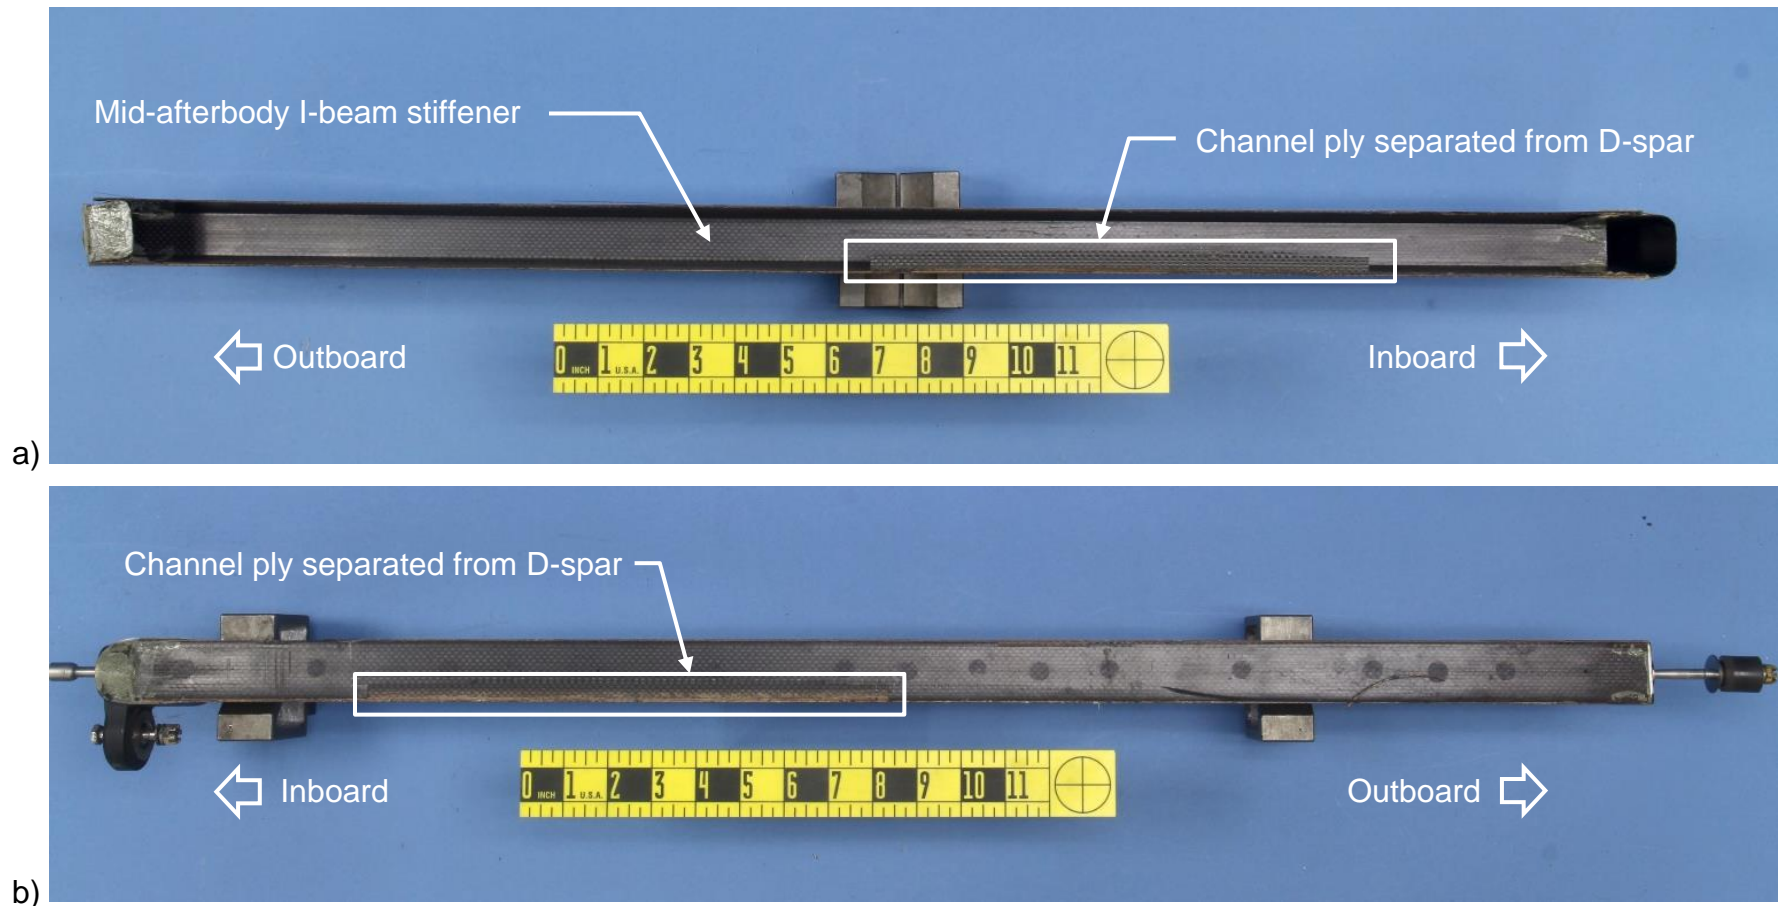
Figure 17. a) Image of the separated servo flap afterbody viewed from the forward direction looking aft and b) image of the servo flap spar / channel ply aft face with portion of C-channel ply peel separated from spar.

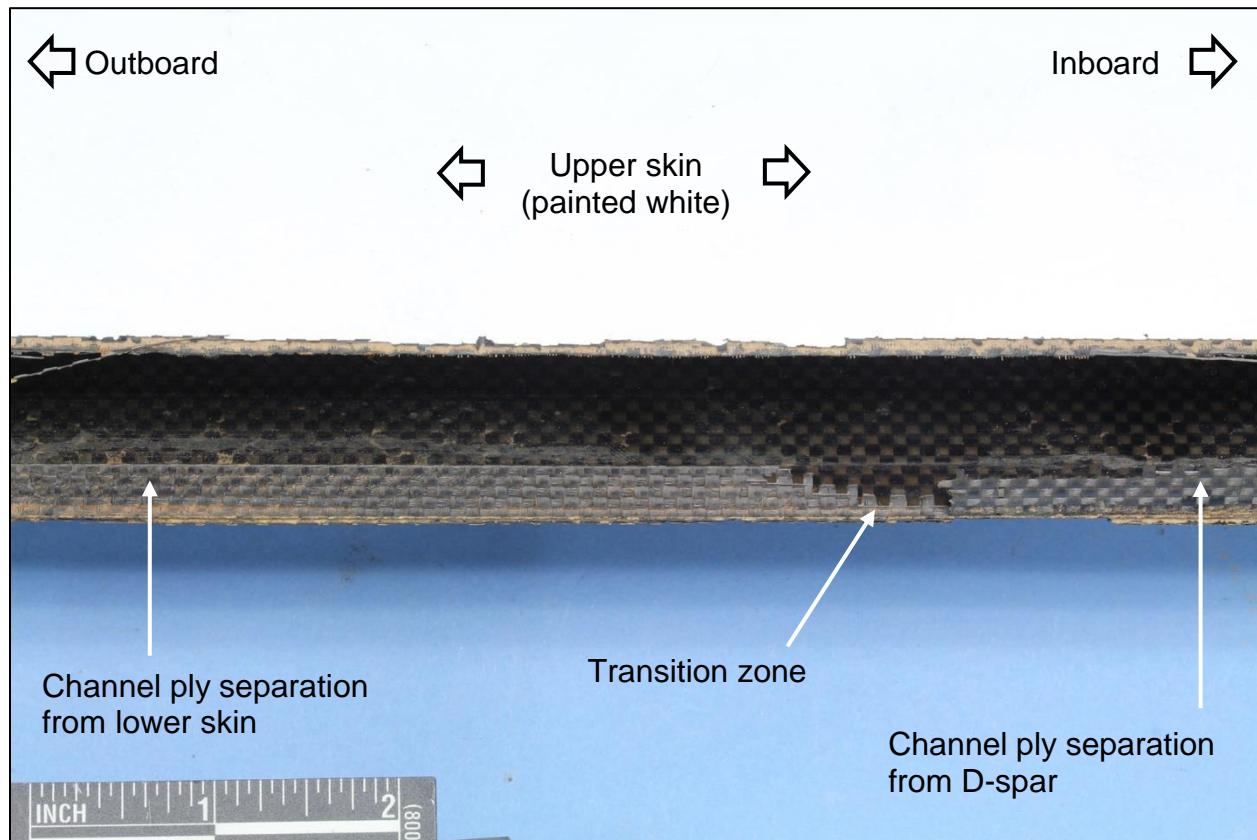
Figure 18. Image of afterbody near the middle (spanwise) where the channel ply transitioned from peel separation from the spar to peel separation from the lower skin.

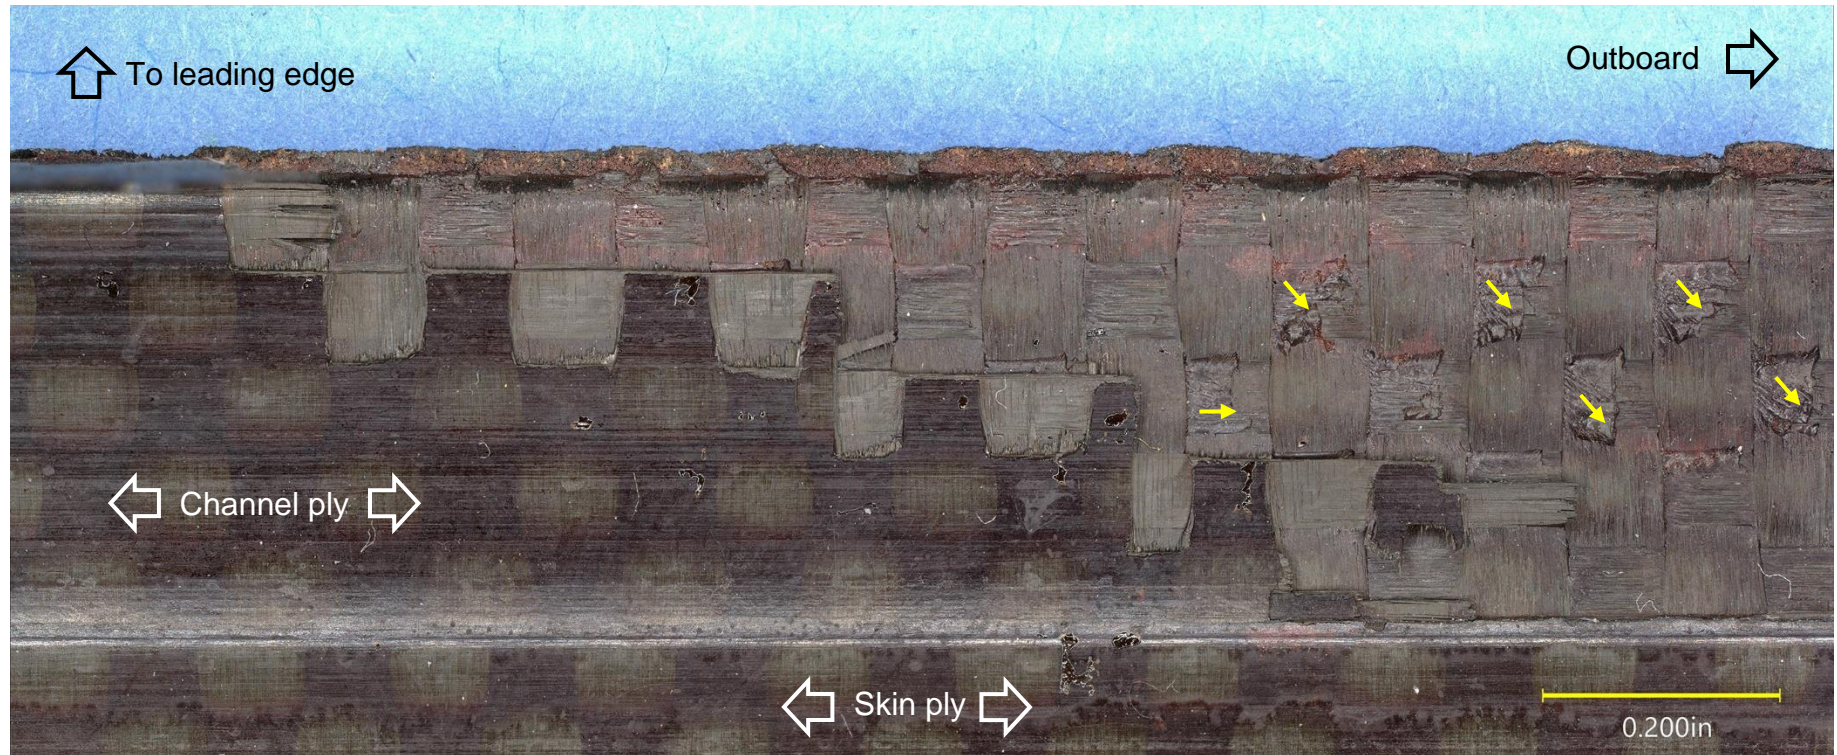
Figure 19. Image showing channel ply peel separation from the lower afterbody skin. Yellow arrows indicate the local direction of crack progression.

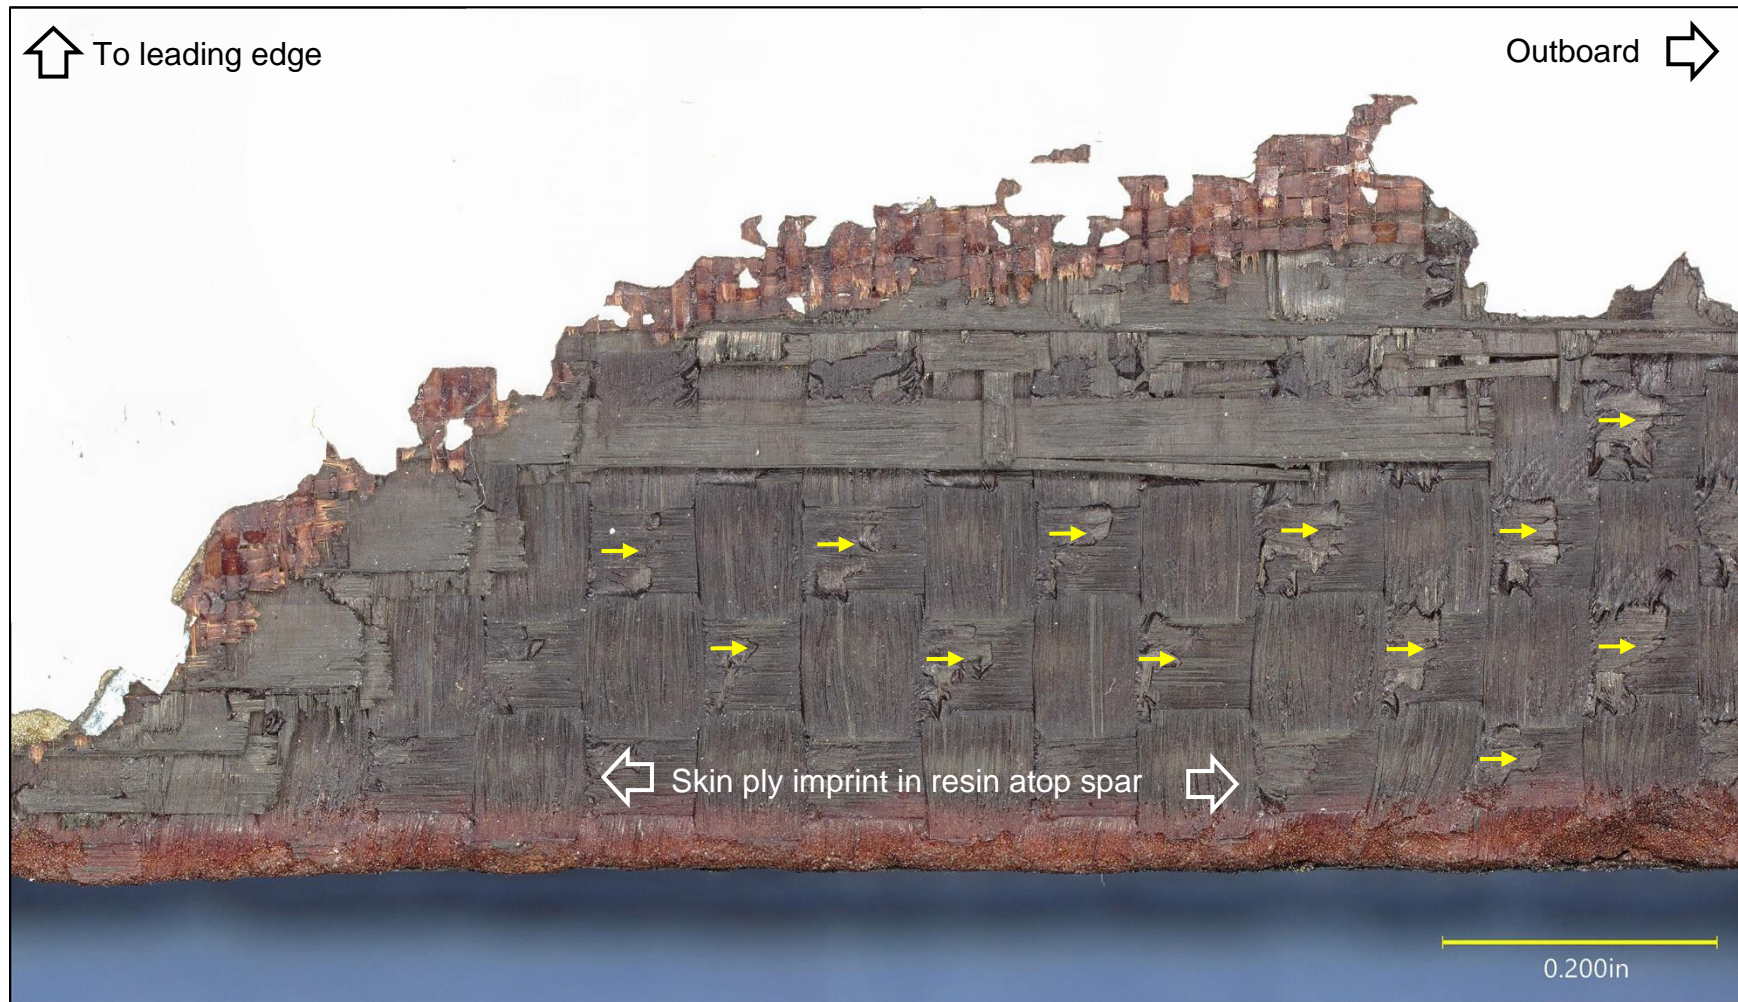
Along the upper surface, the afterbody skin plies initially fractured along the aft edge of the inboard fitting. Immediately outboard of the fitting, the plies began to peel from the spar, as seen in figure 13a and figure 20. The peel region extended approximately 3 inch in the spanwise direction and up to approximately 0.45 inch in the chordwise direction. Similar to the channel ply separation, fractographic examination indicated that the separation occurred primarily along the interface between the inner skin ply's woven fibers and the adjacent interlayer resin with occasional deviations into the resin as it encountered weft-aligned fiber tows. The resin fractures were consistent with the separation proceeding in the outboard direction. Outboard of this region, the skin plies had fractured at or near the spar-to-afterbody transition. Along the outermost 3.5 inch, the outer skin ply exhibited a small peel separation from the inner skin ply on the afterbody-side of the separation, as indicated in figure 13a. The peel extended up to approximately 0.25 inch the chordwise direction.

Figure 20. Image showing upper skin peel separation from inboard region of spar. Yellow arrows indicate the local direction of crack progression.

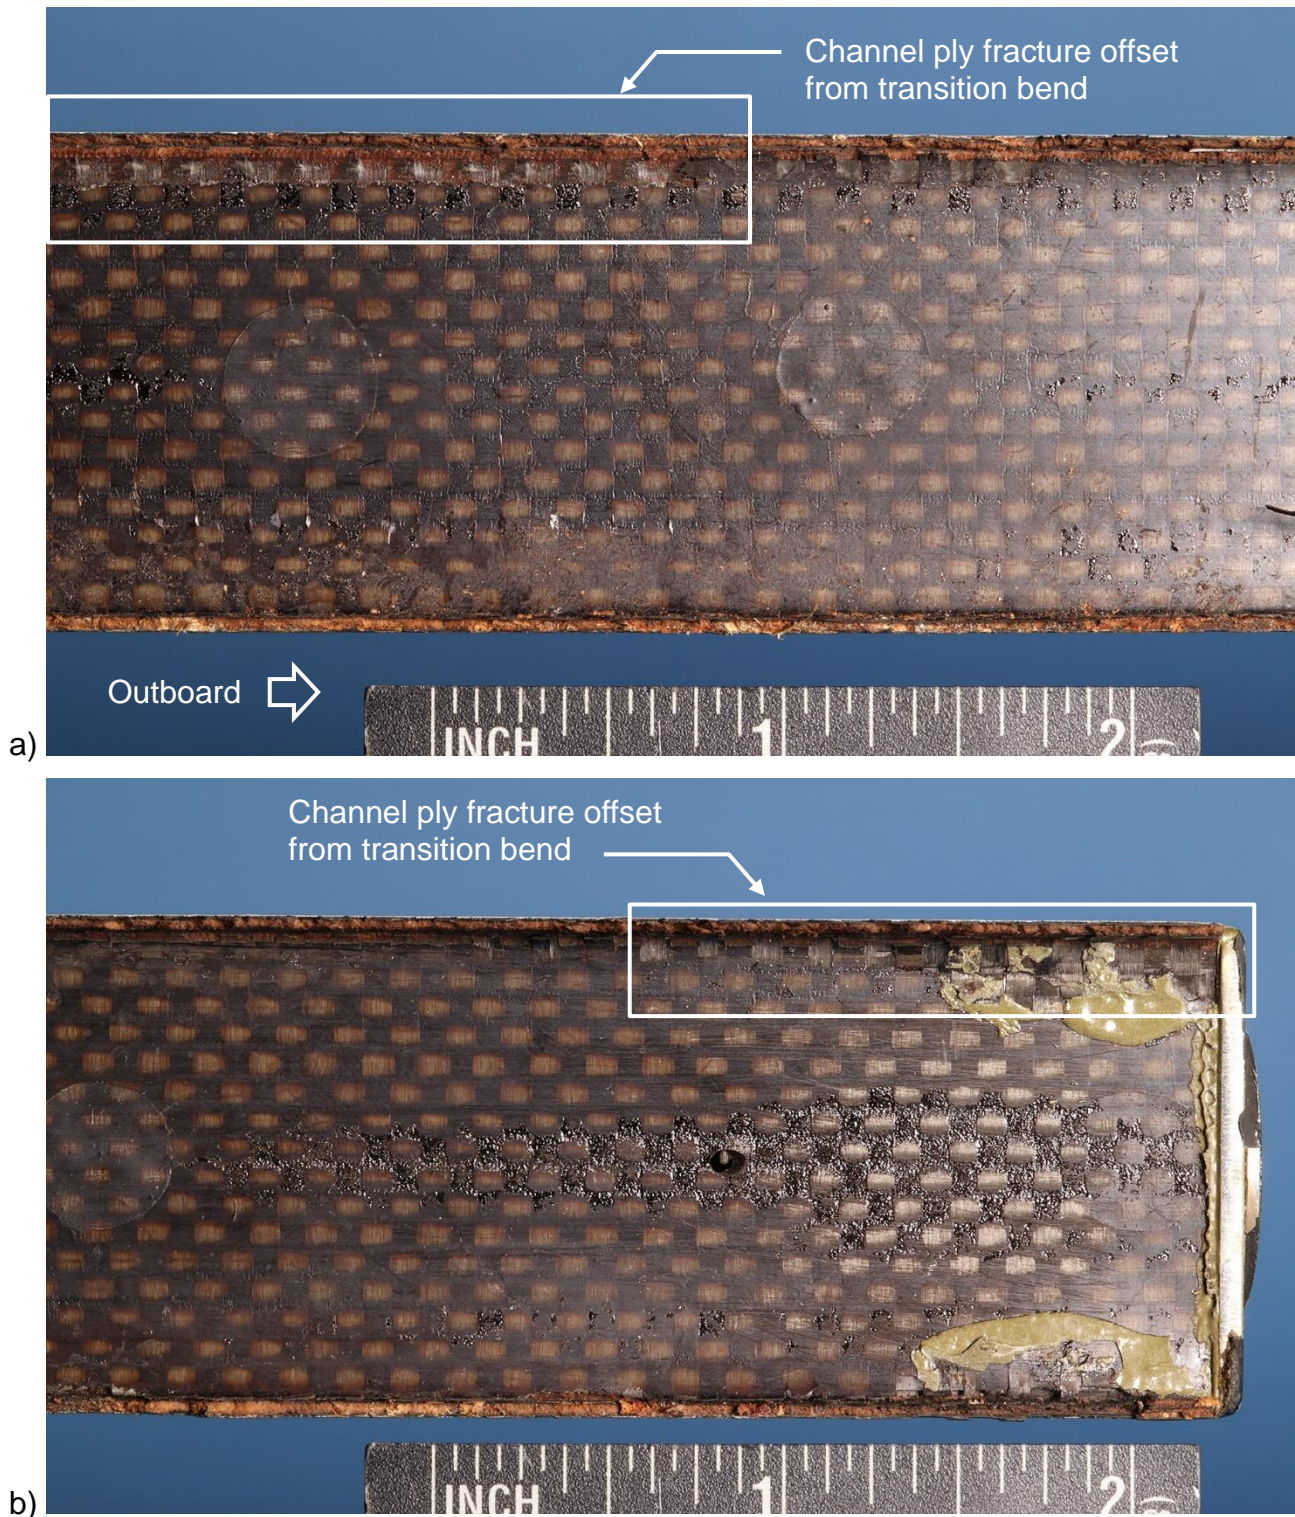
Figure 21. Images of the spar aft face showing regions where the upper channel ply fracture deviated from the transition bend: a) region between STA 19.5 and STA 21.5 and b) region near outboard end.

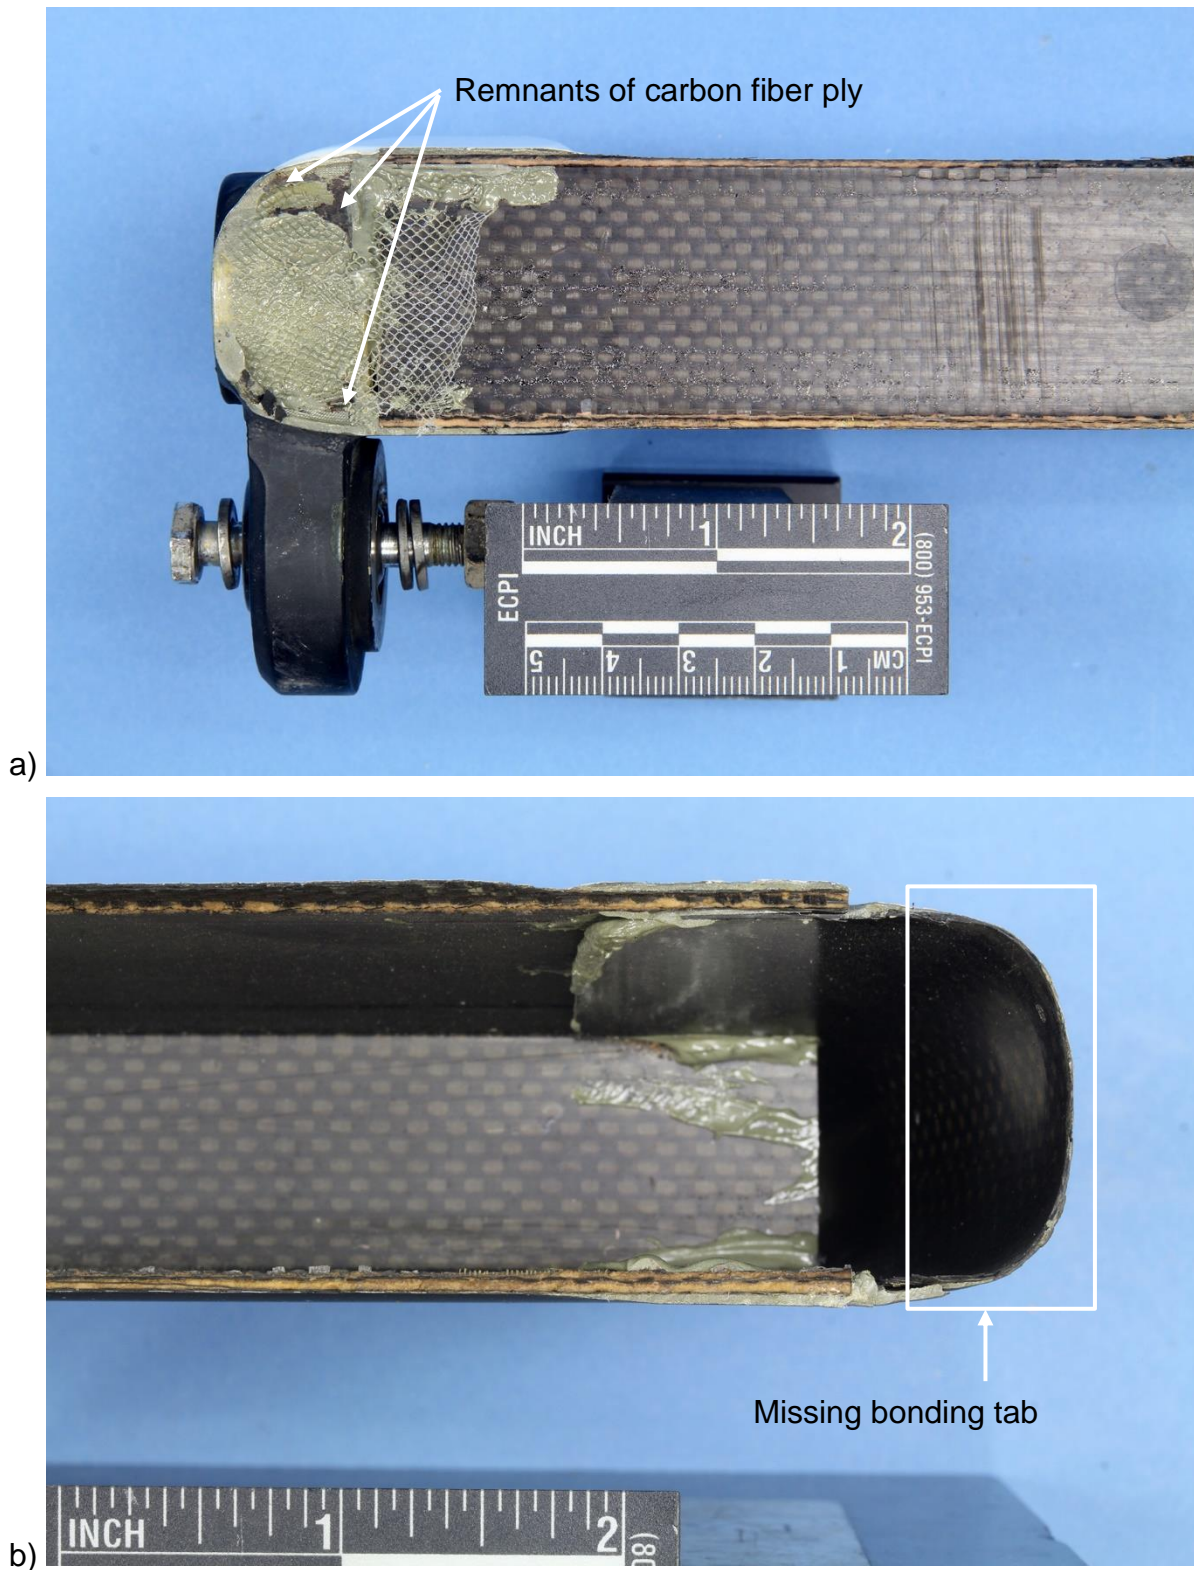
The inboard and outboard closeout fitting bonding tab separations are shown in figures 22 and 23, respectively. As indicated in figure 22b, the bonding tab on the inboard closeout was missing. As seen in figure 22a and figure 24, a green epoxy adhesive and a piece of scrim cloth were used to bond the closeout tab to the aluminum fitting. Much of the area appeared to be unbonded. The adhesive exhibited a smooth and shiny appearance and the diamond pattern from the scrim cloth was visible underneath the adhesive. In some areas, the surface exhibited a dark brown color with a plain weave surface texture that was consistent with a remnant layer from the bonding tab. Around the perimeter of the bonding region, the adhesive had undergone cohesive fracture. The total area and bonded area (cohesive and peeled regions) on the aft face of the fitting were measured on a calibrated image and were approximately 0.871 inch² and 0.227 inch², respectively. The outboard closeout bonding tab, shown in figures 23a and 23b, was also largely unbonded. The total area and bonded area were approximately 1.227 inch² and 0.194 inch², respectively.

Figure 22. Images of the inboard closeout separation: a) spar side and b) afterbody side. The closeout tab for bonding to the inboard aluminum fitting was missing.

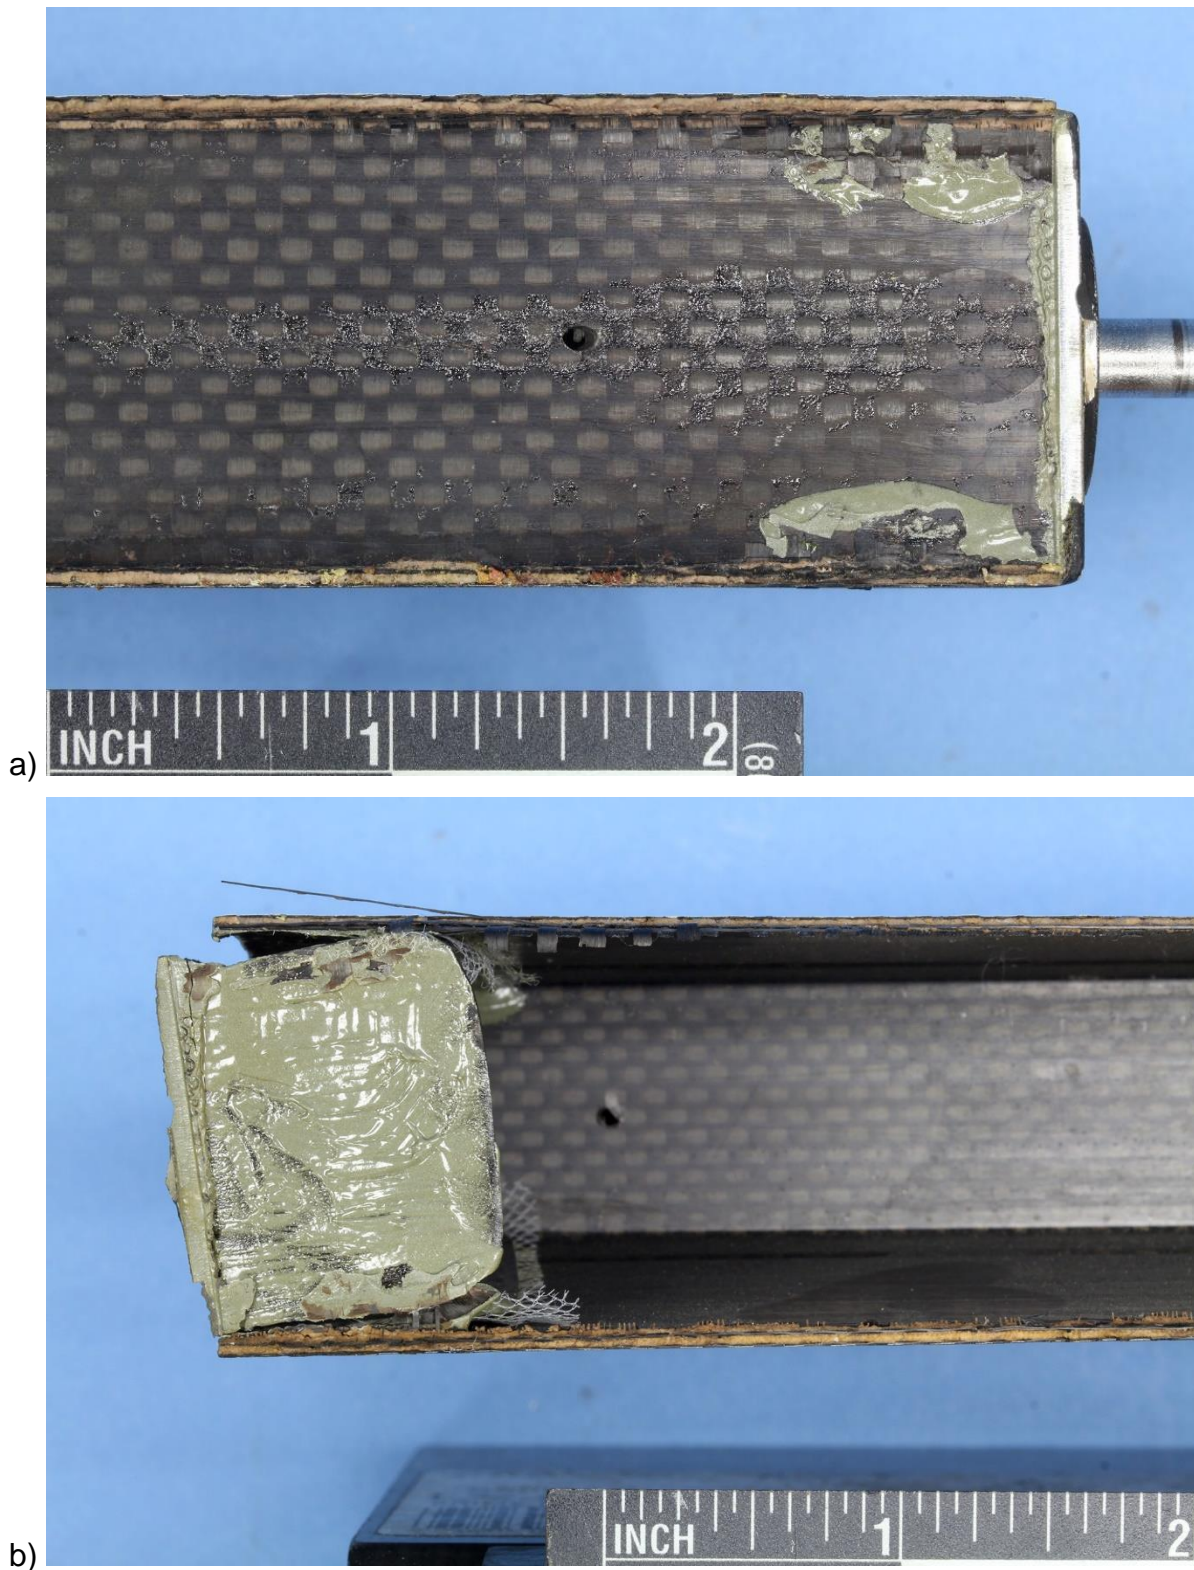
Figure 23. Images of the outboard closeout bonding tab separation: a) spar side and b) afterbody side.

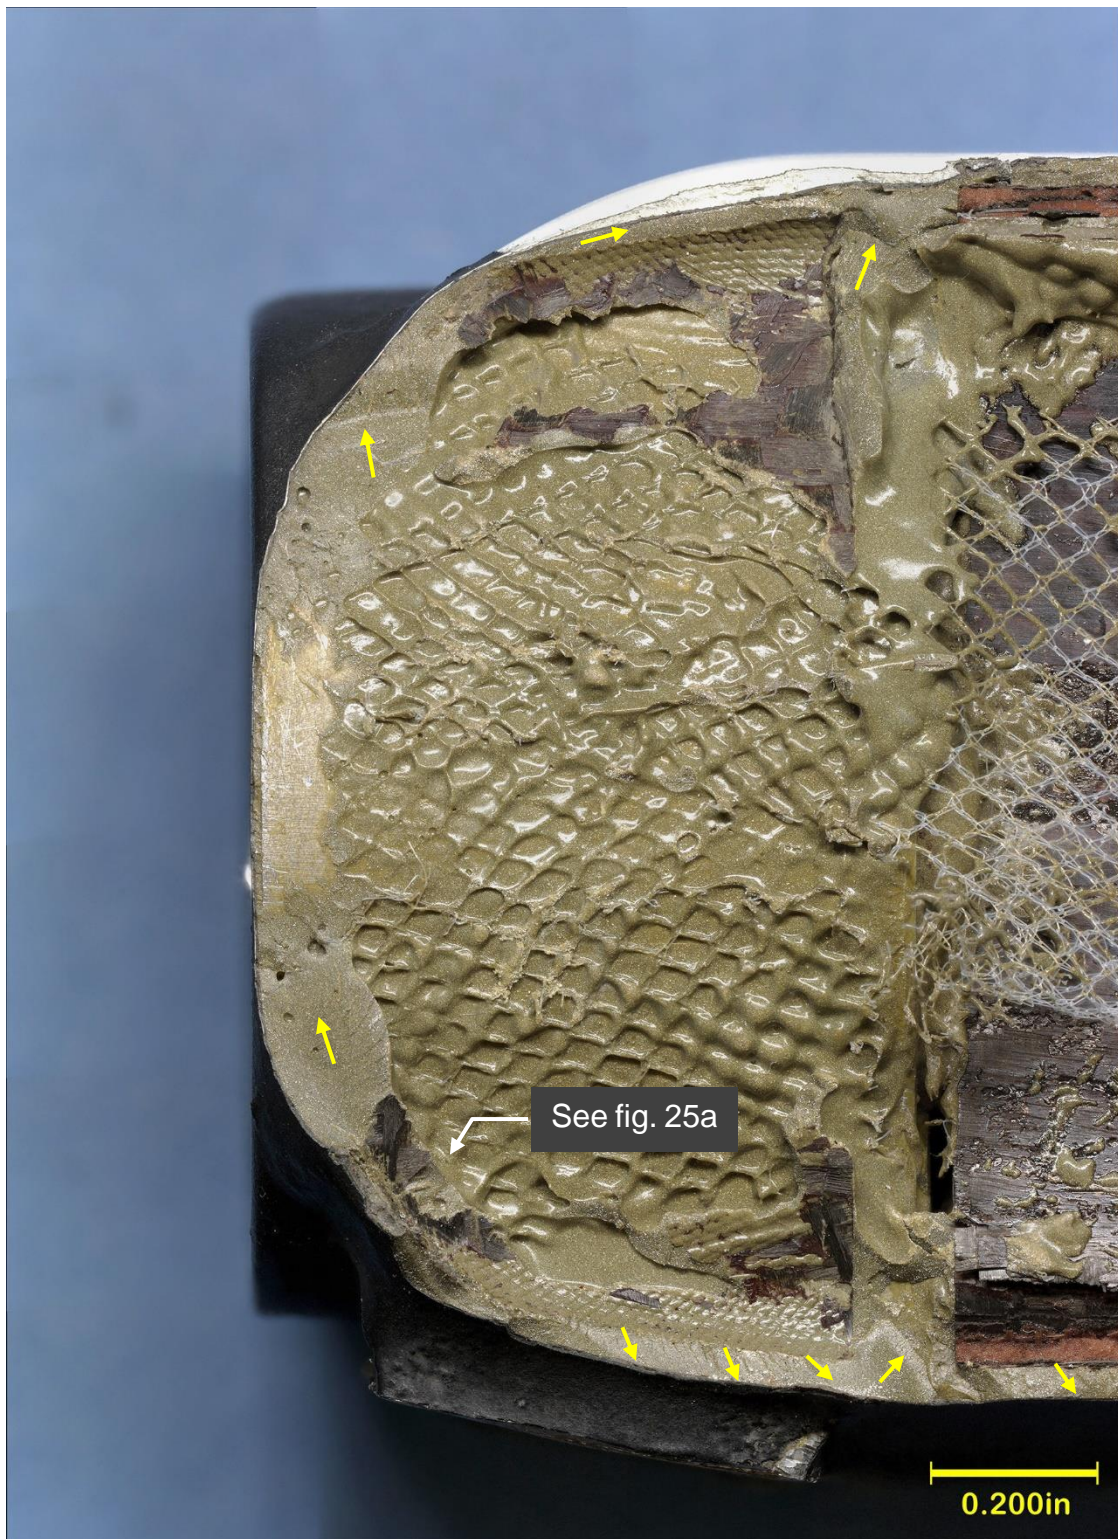
Crack propagation features in the fractured adhesive were used to trace the fracture path around the perimeter back to an origin at the lower inboard location of the bonding region. Figure 24 is annotated with yellow arrows indicating local directions of crack propagation as determined by radiating lines and curved crack arrest marks. Along the lower edge of the bonding region, lines radiated downward and outboard. Along the inboard edge, lines and crack arrest marks were consistent with a crack progressing from the lower side toward the upper side of the fitting. The features traced back to an origin area at the lower inboard region of the perimeter, shown in figures 25a and b. Here the adhesive formed a layer approximately 0.08 inch across, with the outer surface of the flap on one side and the inner cavity of the bonding region on the other. Fracture lines radiated from the inward-facing side of the layer initiating at or near the interface with the carbon fiber bonding ply (figure 25a). Along one half of the origin, the fracture proceeded along the adhesive/ply interface. Along the other half, the fracture diverted away from the interface, starting as a cohesive fracture through the adhesive. The cohesive fracture progressed approximately 0.04 inch across the adhesive layer before diverting into and continuing along the adhesive/ply interface. The crack progressed away from the origin along two fronts. One front progressed outboard along the lower surface to the lower edge of the afterbody. The other front progressed up along the inboard side, then outboard across the upper surface to the upper edge of the afterbody.

Figure 24. Aft face of the aluminum fitting exhibiting adhesive, scrim cloth, and peel separation of a carbon fiber ply.

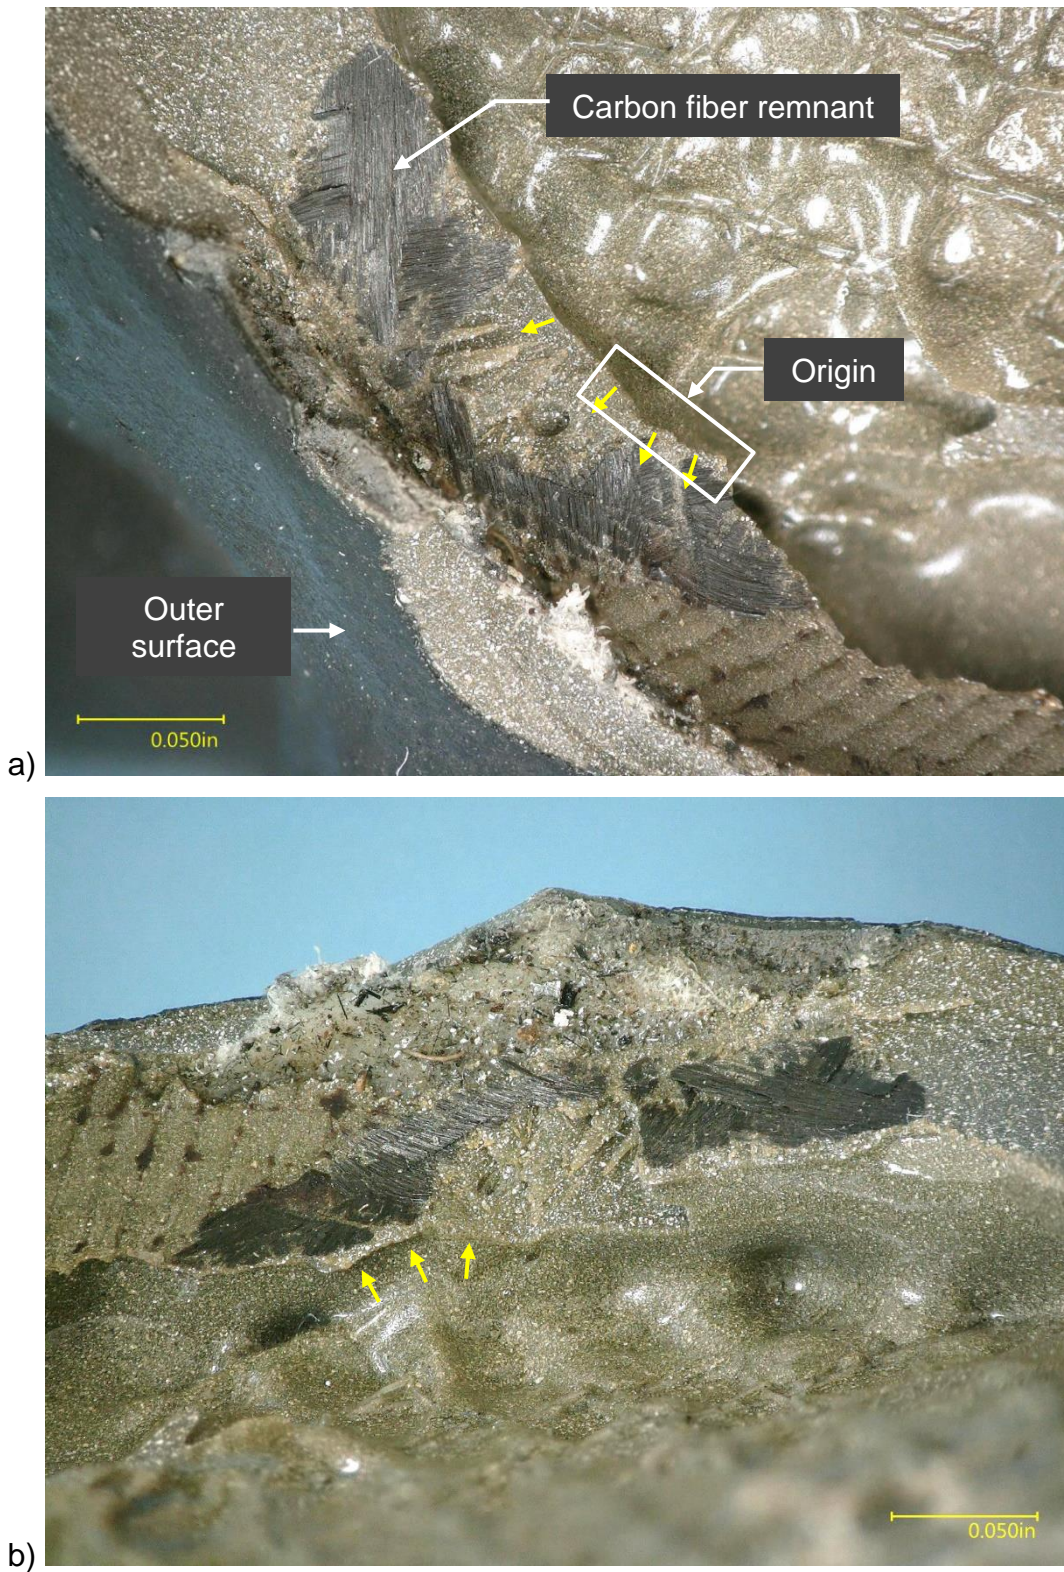
Figure 25. Images of the inboard closeout fracture origin area: a) plan view and b) oblique view.

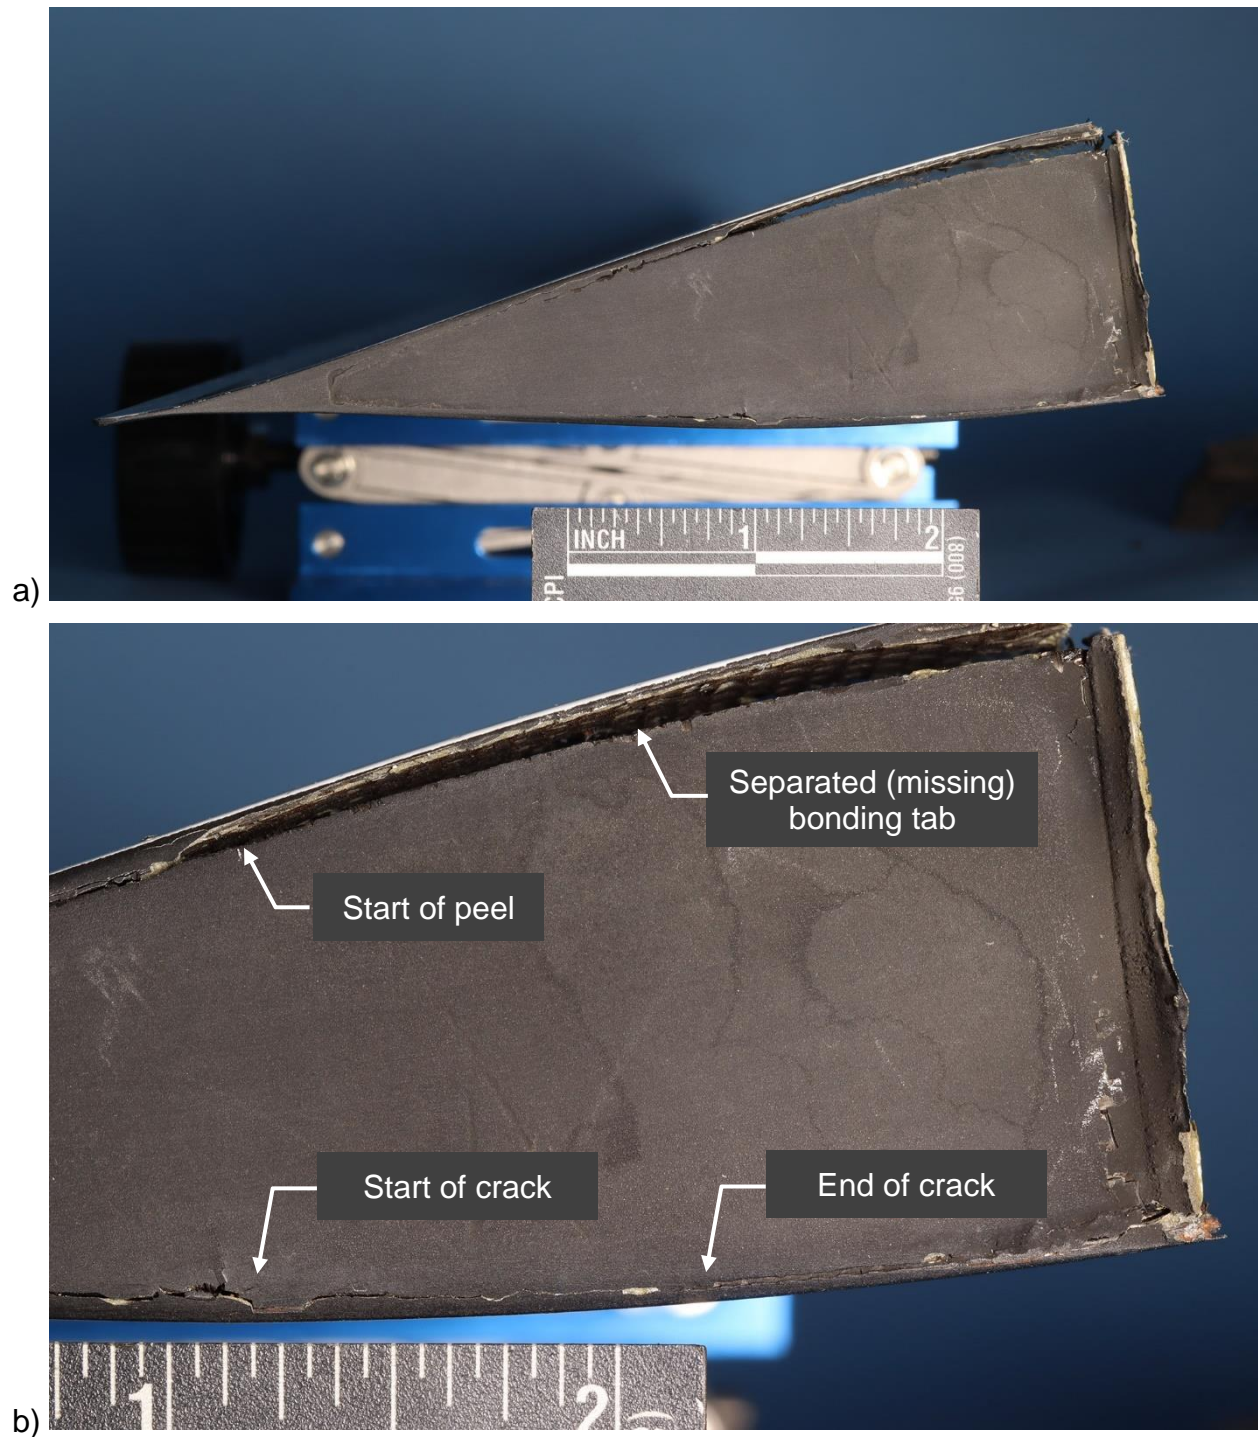
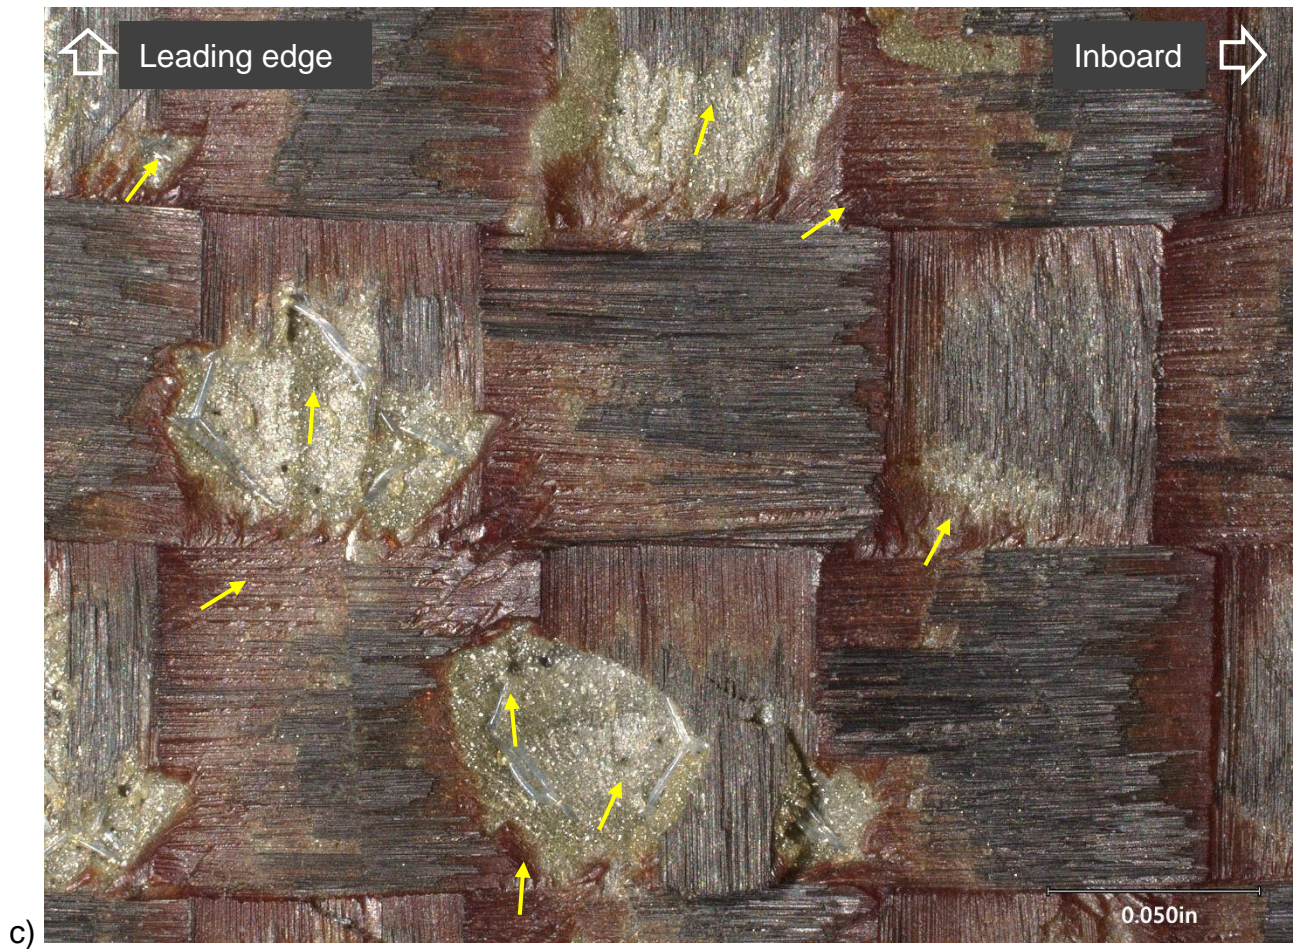
The outboard closeout was cracked along the upper and lower edges of the bond line with the afterbody as seen in figures 26a and b. The crack along the lower edge started near a midbody I-beam stiffener and progressed forward and aft approximately 1 inch, arresting before reaching the spar or trailing edge. Along the upper edge, a crack also extended forward and aft of the I-beam and a closeout tab that was bonded to the forward portion of the upper afterbody skin was missing. The tab had peeled from the skin leaving adhesive and carbon fiber ply imprints behind. Examination of the delamination

surface indicated that the tab delamination proceeded inboard and toward the leading edge, as indicated in figure 26c.

Figure 26. Images of the outboard closeout: a) overview; b) image indicating end of crack along lower edge and peel region of bonding tab along upper edge; and

c) **Figure 26 (cont.).** c) Upper skin, interior surface at outboard end of the flap where an outboard closeout bonding tab had separated. Local crack propagation marks in the adhesive and resin, indicated by yellow arrows, point toward the leading edge and the inboard direction.
